Metricon stadium training field

20,000m²

CIRCULAR DRAINAGE SYSTEM

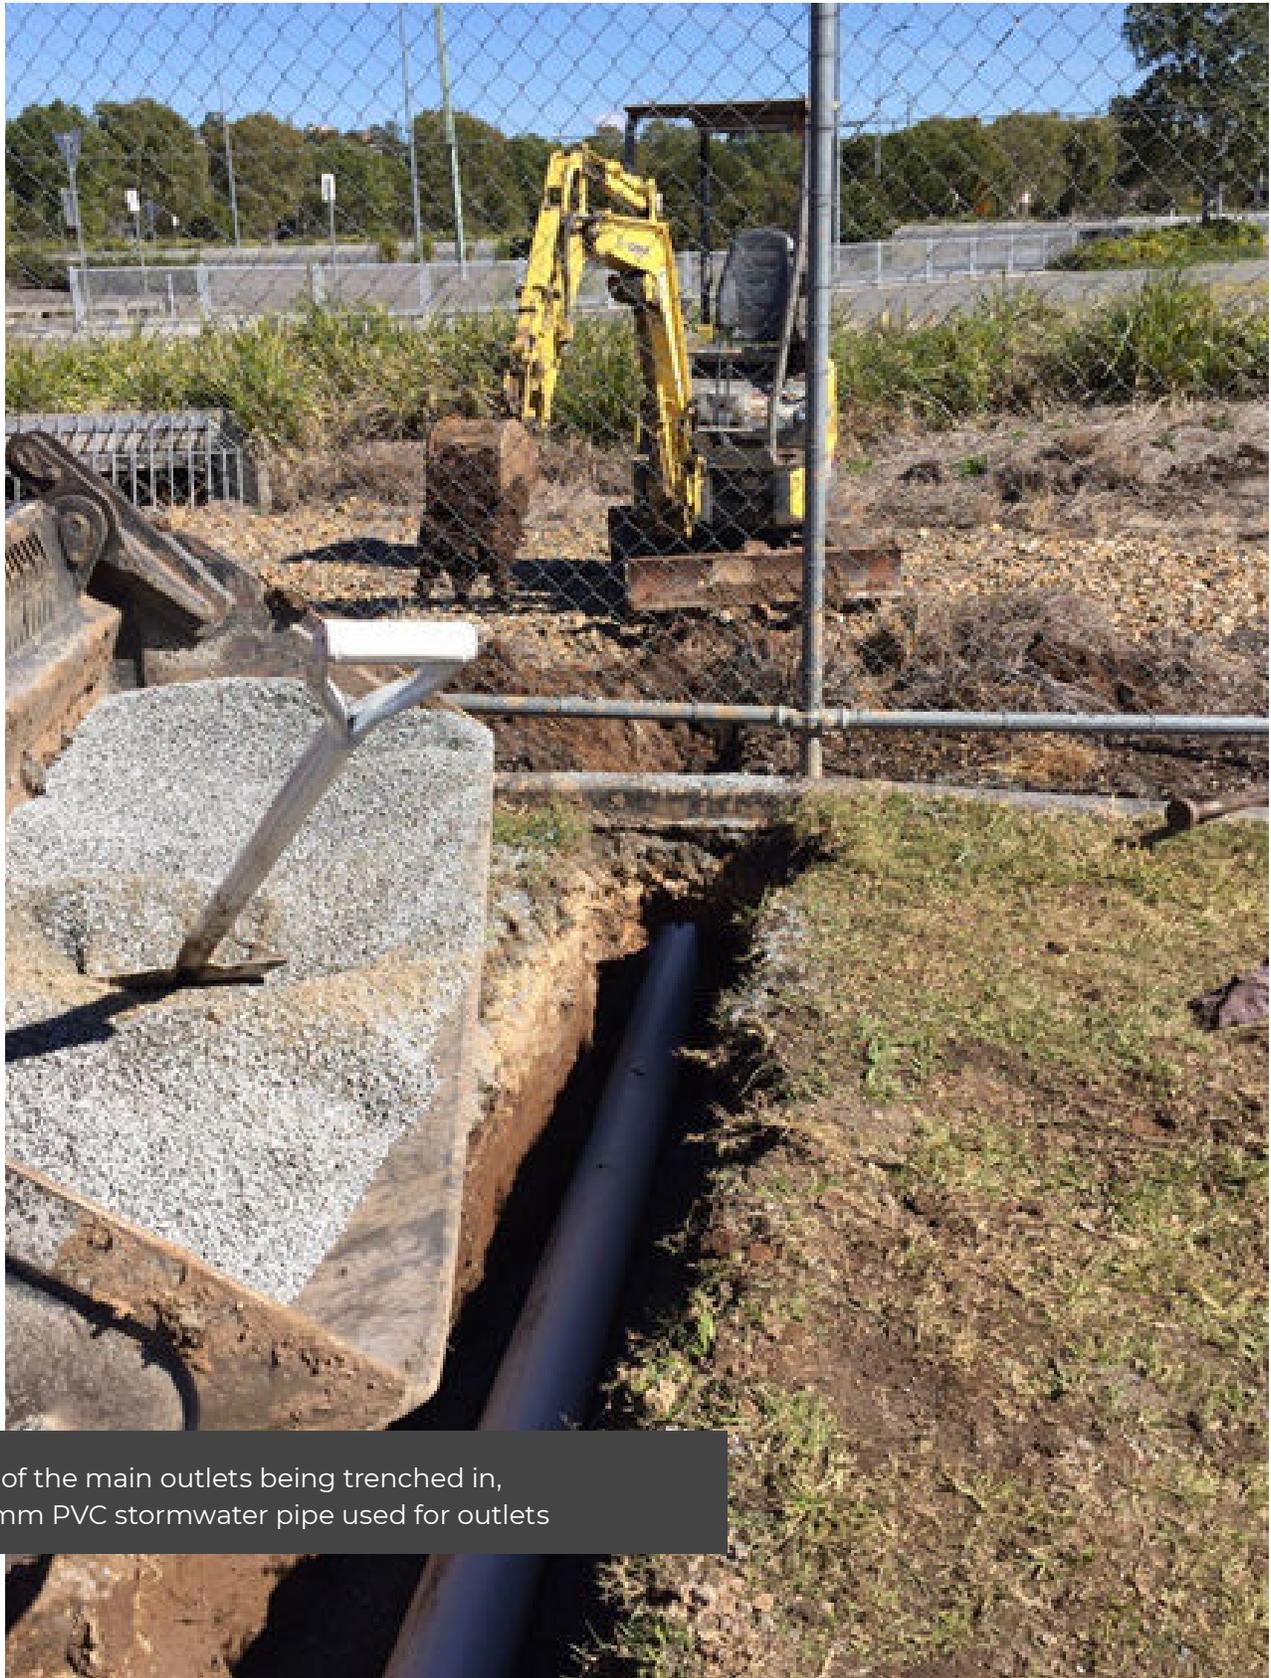
One of the main outlets being trenched in, 200mm PVC stormwater pipe used for outlets

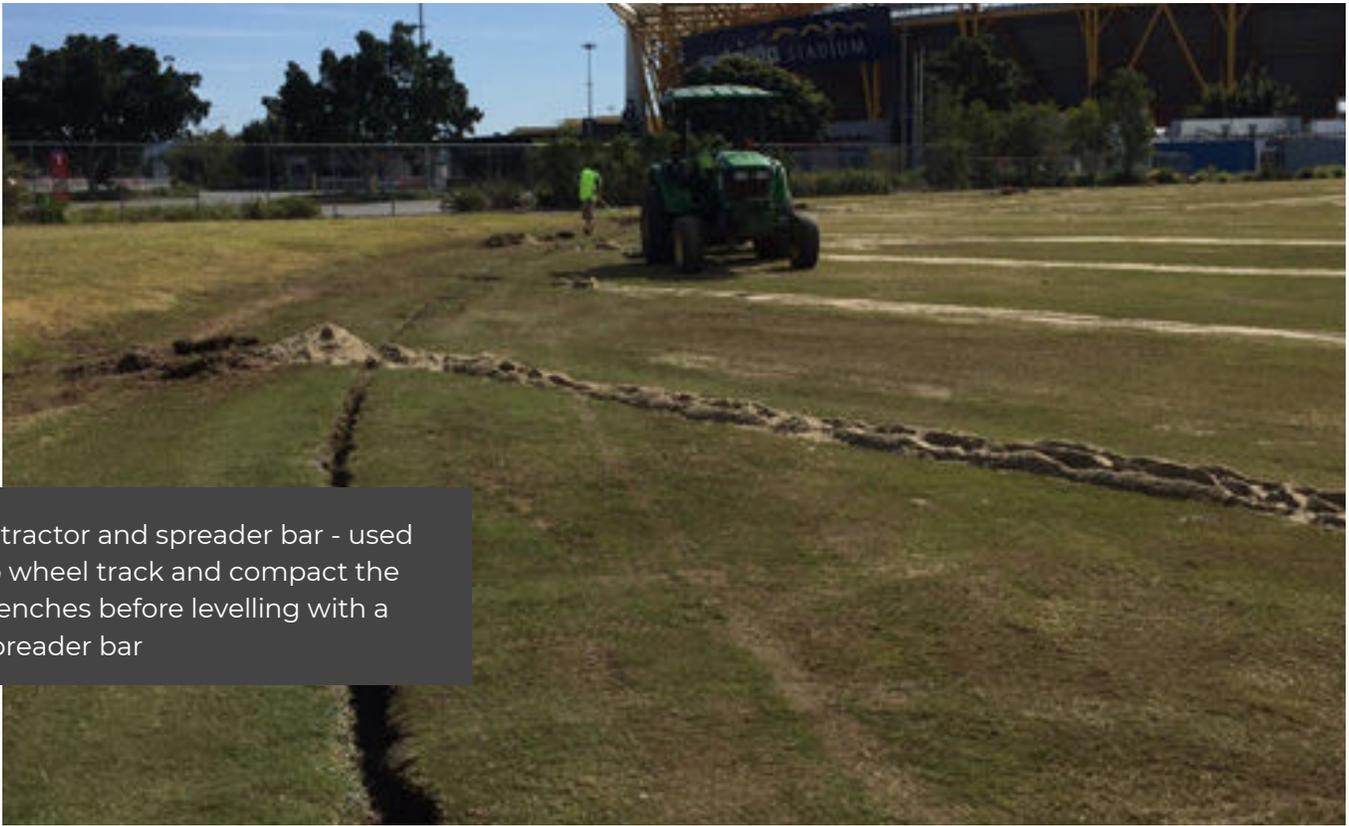
A tractor and spreader bar - used to wheel track and compact the trenches before levelling with a spreader bar

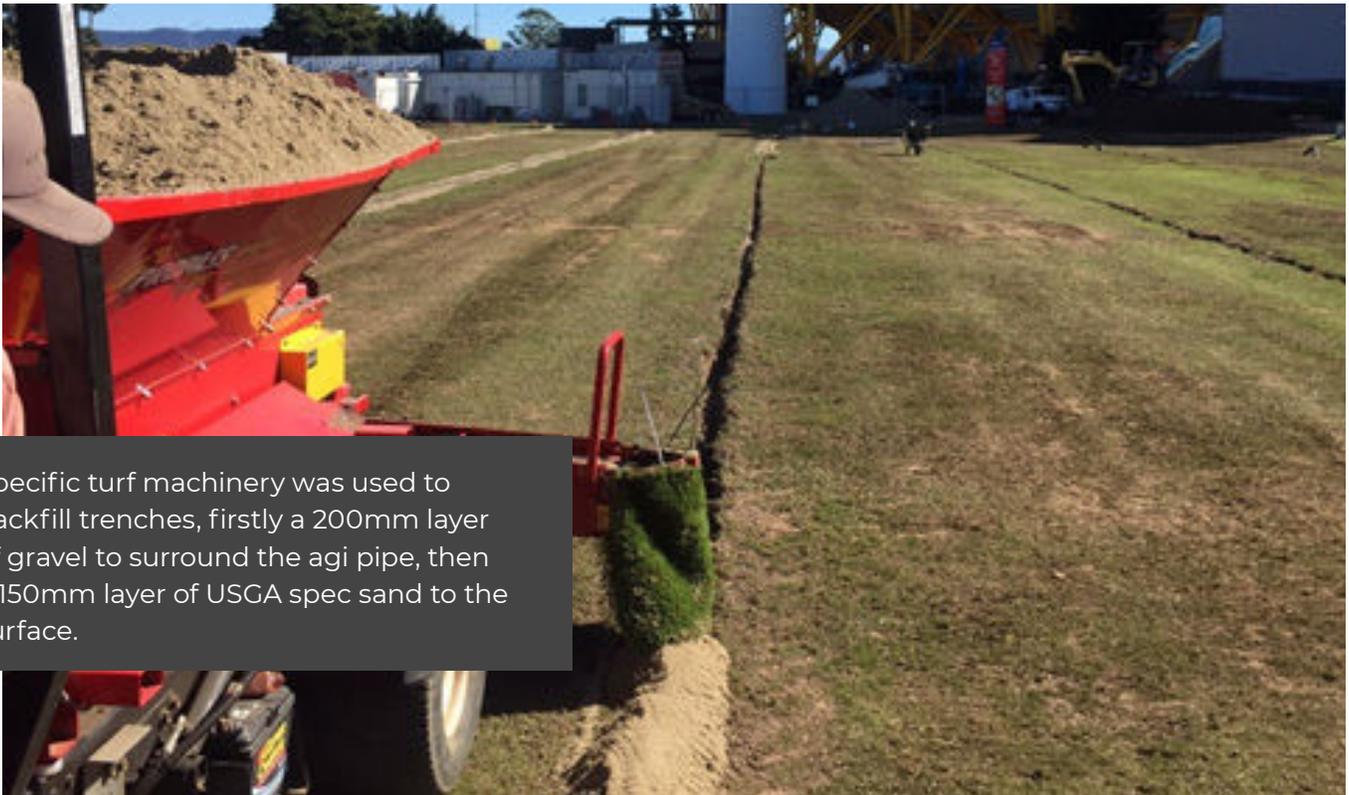
Specific turf machinery was used to backfill trenches, firstly a 200mm layer of gravel to surround the agi pipe, then a 150mm layer of USGA spec sand to the surface.

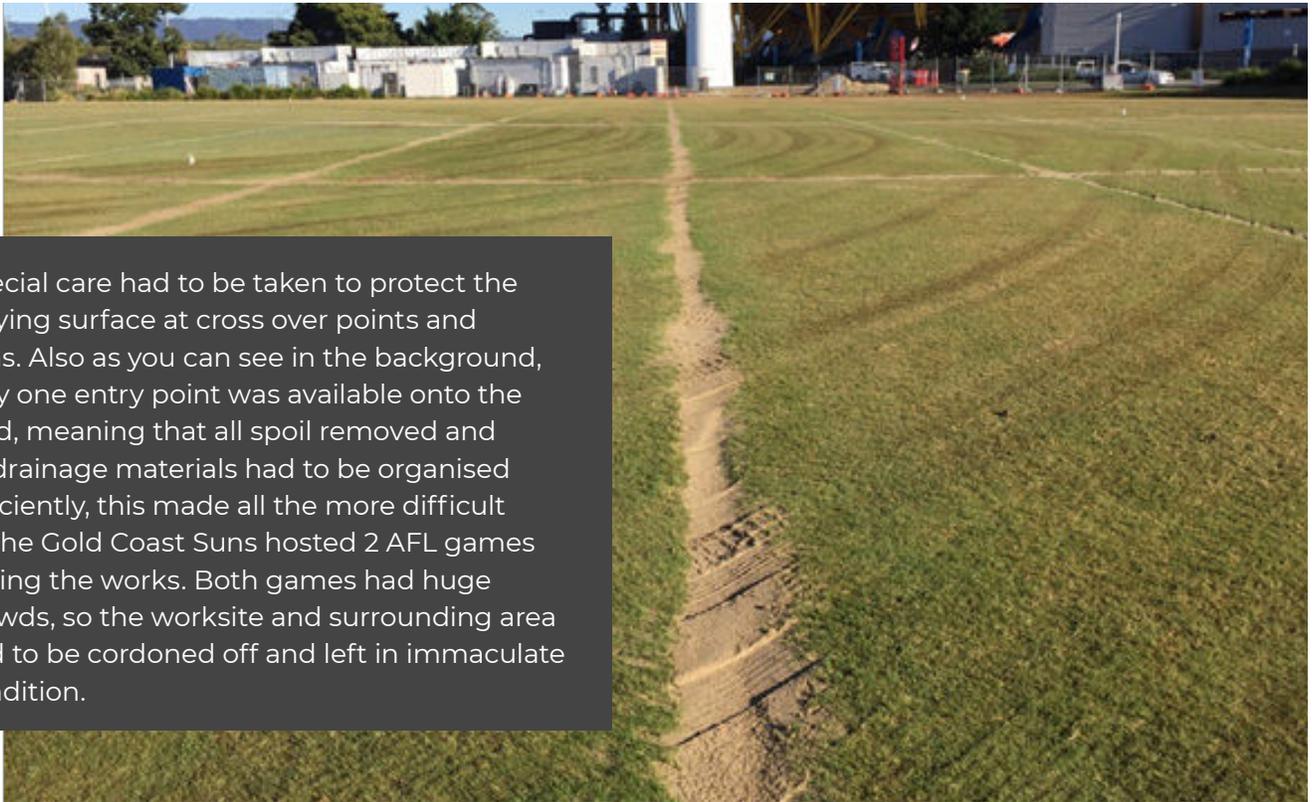
Special care had to be taken to protect the playing surface at cross over points and joins. Also as you can see in the background, only one entry point was available onto the field, meaning that all spoil removed and all drainage materials had to be organised efficiently, this made all the more difficult as the Gold Coast Suns hosted 2 AFL games during the works. Both games had huge crowds, so the worksite and surrounding area had to be cordoned off and left in immaculate condition.

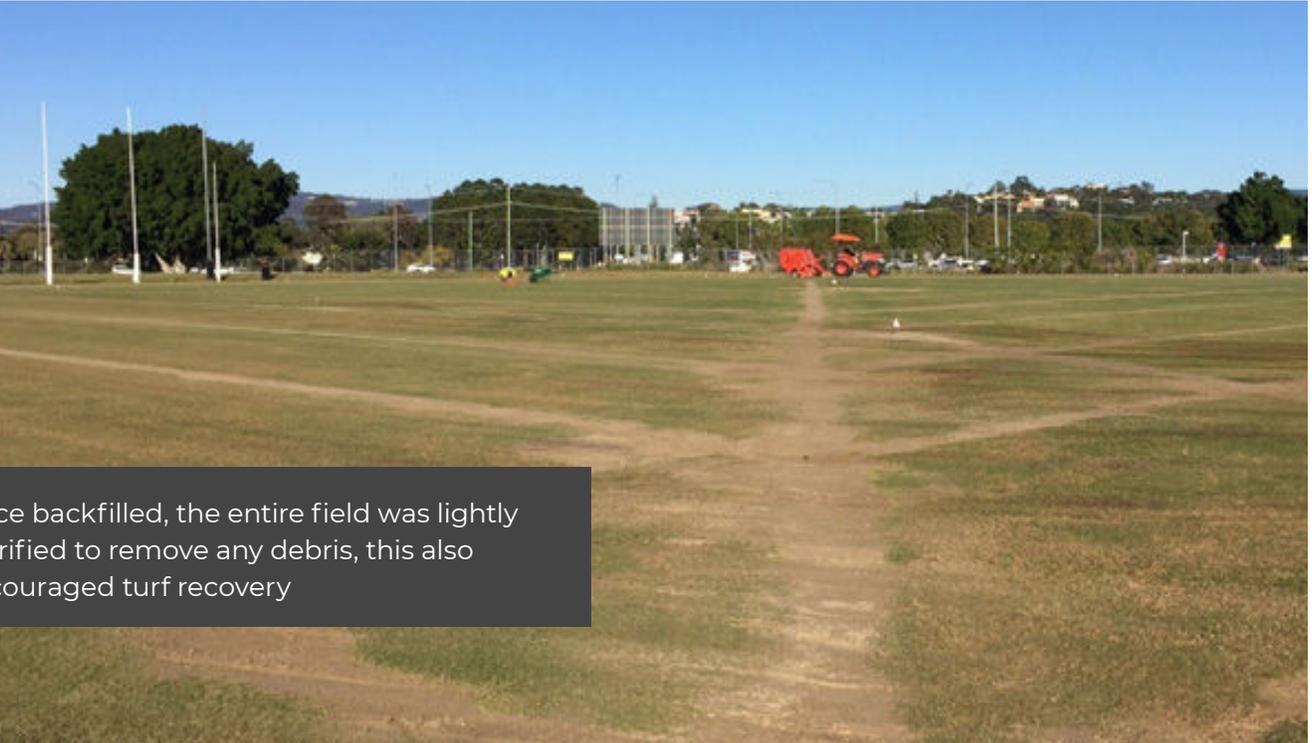
Once backfilled, the entire field was lightly scarified to remove any debris, this also encouraged turf recovery

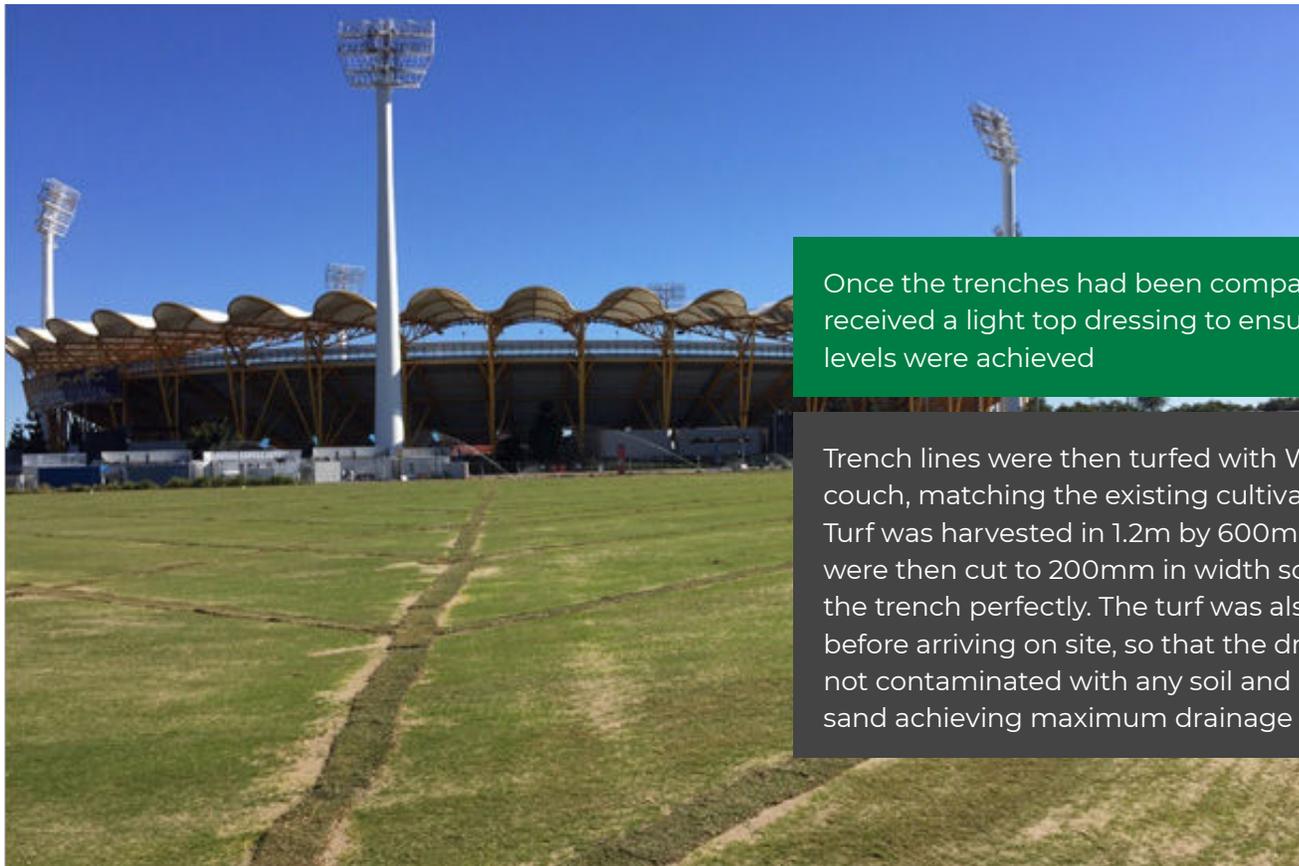
Once the trenches had been compacted, the field received a light top dressing to ensure the perfect levels were achieved

Trench lines were then turfed with Wintergreen couch, matching the existing cultivar on the field. Turf was harvested in 1.2m by 600mm slabs which were then cut to 200mm in width so as to cover the trench perfectly. The turf was also washed before arriving on site, so that the drain lines were not contaminated with any soil and remained pure sand achieving maximum drainage capacity.

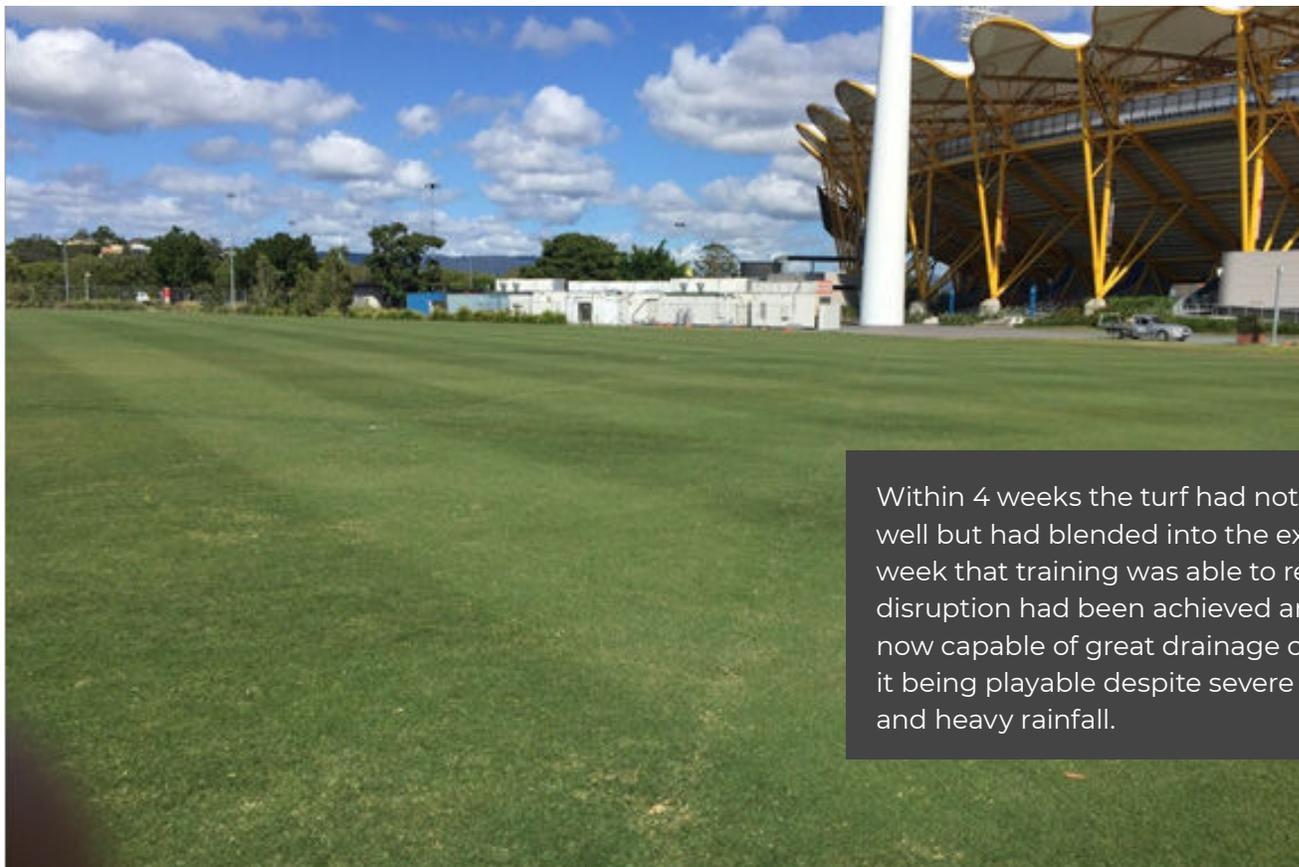
Within 4 weeks the turf had not only taken well but had blended into the existing field so well that training was able to resume. Minimal disruption had been achieved and a field was now capable of great drainage characteristics, it being playable despite severe thunderstorms and heavy rainfall.
